UNITED STATES ENVIRONMENTAL PROTECTION AGENCY, REGION 2
Caribbean Environmental Protection Division
City View Plaza II, #48 Carr 165 Ste 7000
Guaynabo, Puerto Rico 00968-8073

August 3, 2017

Mr. Manuel Mata
President
AES Puerto Rico, L.P.
P. O. Box 1890
Guayama, Puerto Rico 00785

Re: Notice of Site Visit Findings and Proposed Actions Pursuant to Sections 301(a) and 402 of the Clean Water Act; 2015 MSGP Tracking Number PRR053093

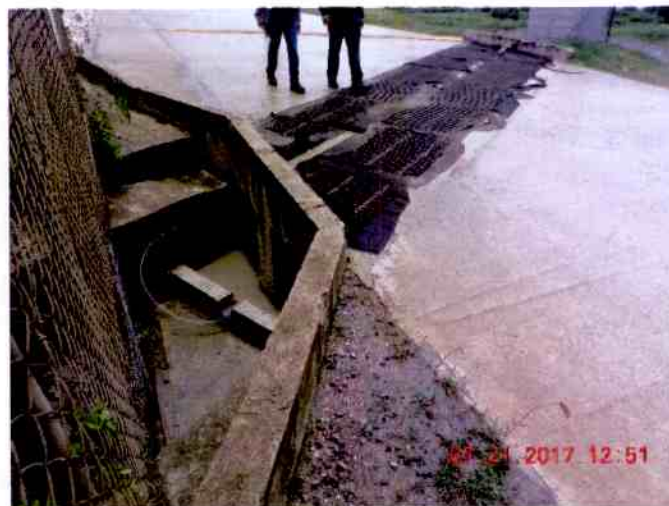
Picture 1

a. **Finding 1** (Picture 1 below depicts this observation):

- ⇒ A rain event took place during the walkthrough at the Agremax pile area and outfall 002.
- ⇒ The iron discharge concentration through storm water outfall 002 continues to be greater than the benchmark value established in Part 8.O.1 of the MSGP.
- ⇒ The storm water runoff reaching outfall 002 had the same color as Agremax.

MSGP Requirements: Part 4 and Part 6.2.1.2 (review the control measures and perform any required corrective action immediately).

- ⇒ Divert and reuse the runoff first flush in all storm water discharges thru outfall 002.
- ⇒ Implement additional best management practices to bring the iron concentration below the benchmark value.³

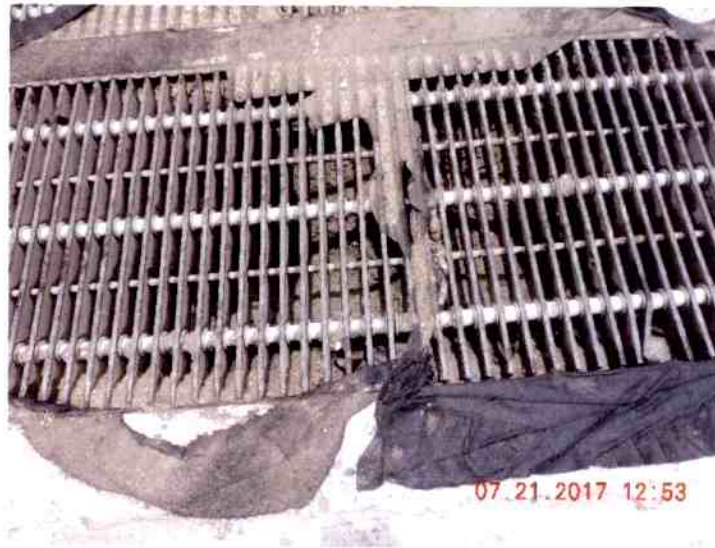
Picture 2

b. **Finding 2** (Picture 2 below depicts this observation):

- ⇒ The filter fabric installed at the metal bar grate near outfall 002 was observed with significant accumulation of solids and deteriorated.

MSGP Requirement: Part 2.1.2.3 (maintain all control measures in effective operating conditions).

- ⇒ Clean the catch basin
- ⇒ Replace the filter fabric

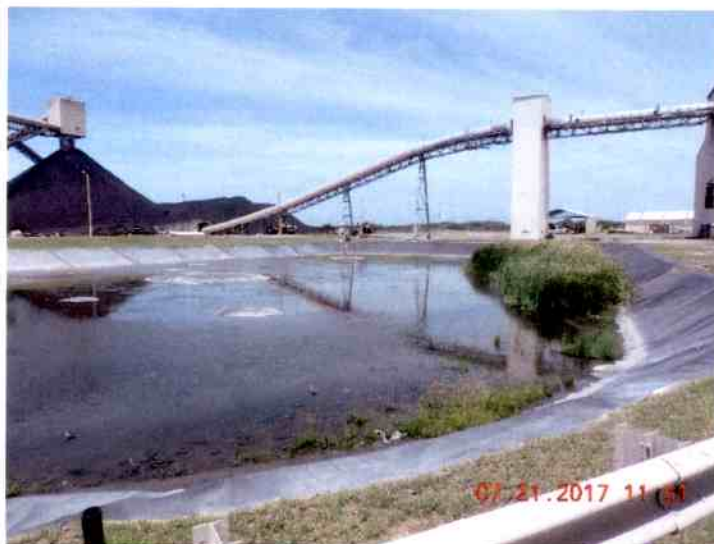
Picture 3

c. **Finding 3** (Picture 3 below depicts this observation):

⇒ The storm water pond was not properly maintained, and was covered with significant vegetation growth.

MSGP Requirement: Part 2.1.2.3 (maintain all control measures in effective operating conditions).

⇒ Remove all vegetation from the storm water pond

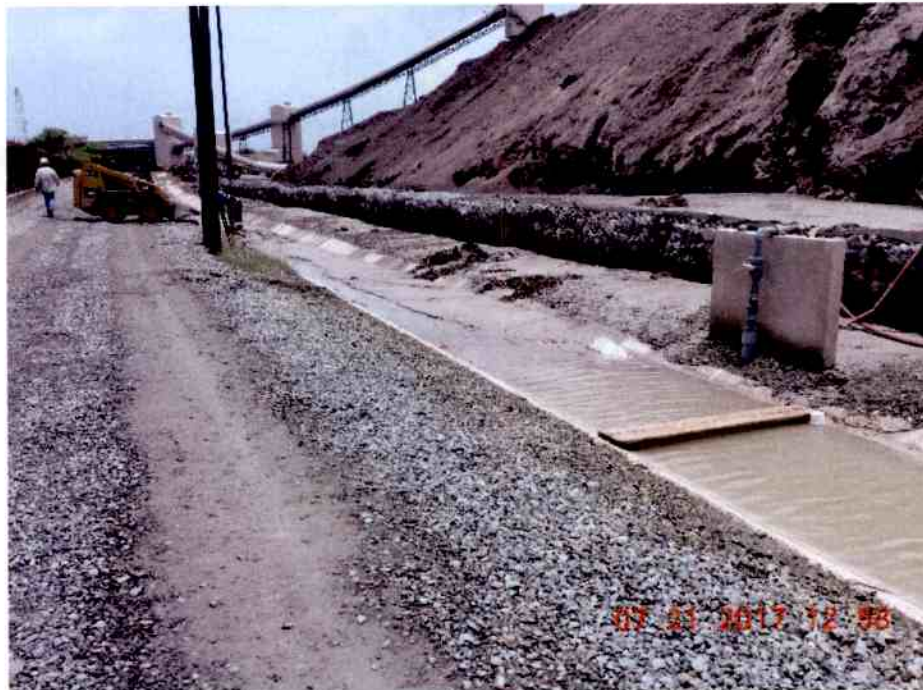
Picture 4

d. **Finding 4** (Picture 4 below depicts this observation):

⇒ A portion of the concrete storm water conveyance ditch located at the south side of the Agremax pile was observed covered with Agremax.

MSGP Requirement: Part 2.1.2.3 (maintain all control measures in effective operating conditions).

⁴ EPA observed a person cleaning the ditch during the course of the walkthrough.

⇒ The concrete storm water conveyance ditch shall be cleaned to allow for free/uninterrupted flow.⁴

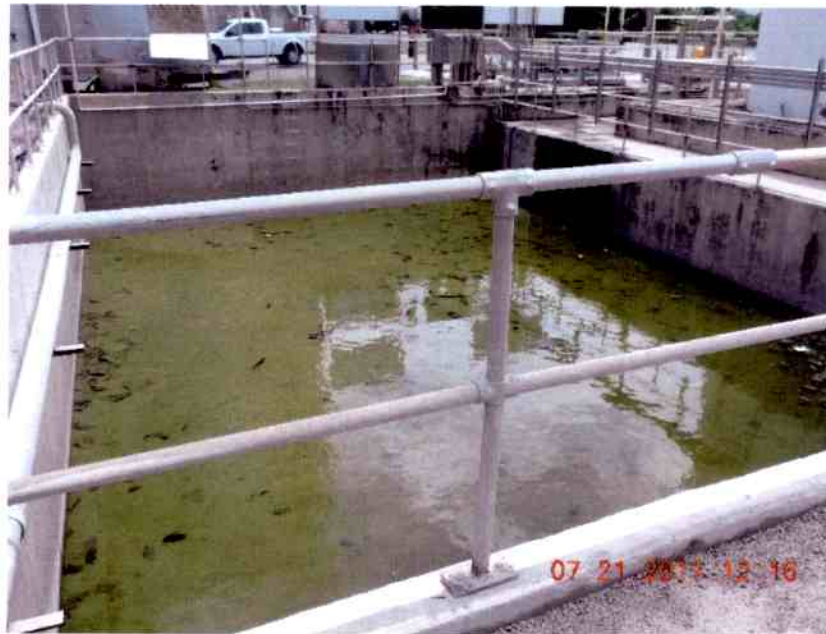
Picture 5

e. **Finding 5** (Picture 5 below depicts this observation):

⇒ The diesel spill control tank had a discolored water accumulation and floating material.

MSGP Requirement: Part 2.1.2.3 (maintain all control measures in effective operating conditions).

⇒ The diesel spill control tank shall be emptied and cleaned of sediments and other materials.

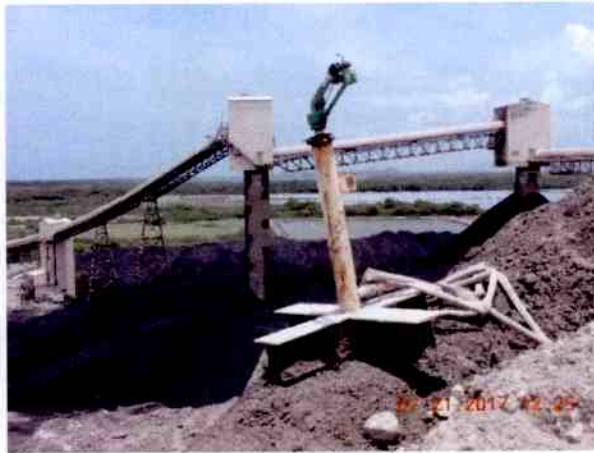
Picture 6

- f. **Finding 6** (Pictures 6, 7, 8 and 9 below depict certain locations in which the water sprinkler system was not observed in use and slope surfaces were not wet):

- ⇒ The water sprinkler system for dust minimization at the Agremax pile was not in use.
- ⇒ Certain areas of the Agremax pile were dry and without dust control water application.

MSGP Requirement: Part 2.1.2.10 (minimize generation of dust)

- ⇒ Operate the water sprinkler system on all areas in which the Agremax is exposed at the pile in accordance with Part 6.3 of the Dust Control Plan and the Storm Water Pollution Prevention Plan (SWPPP) developed for the Facility.

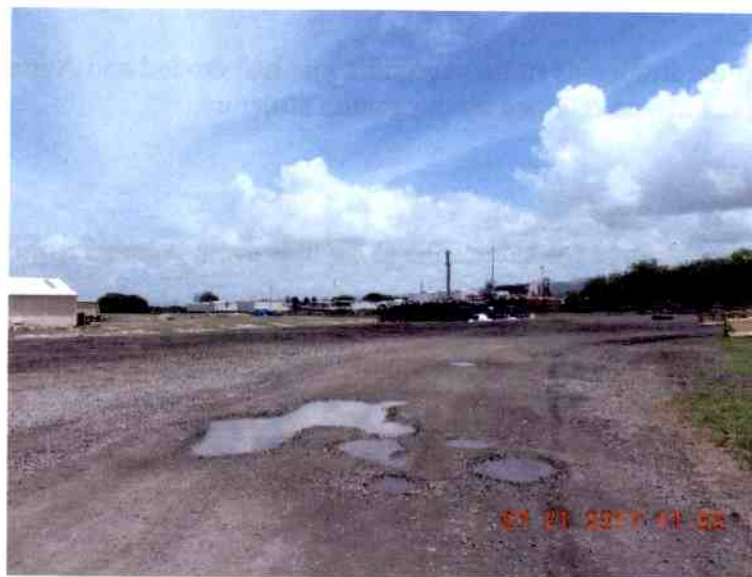
Picture 10

h. **Finding 8** (Picture 10 below depicts an example of this observation):

- ⇒ Areas of exposed soil (i.e. soil patches lacking crushed stone cover) near the water treatment facility, storm water pond, and internal road on the south side of the Facility lacked soil stabilization.

MSGP Requirement: Part 2.1.2.5 (erosion and sediment control)

- ⇒ Re-apply crushed stone to cover those areas lacking soil stabilization.

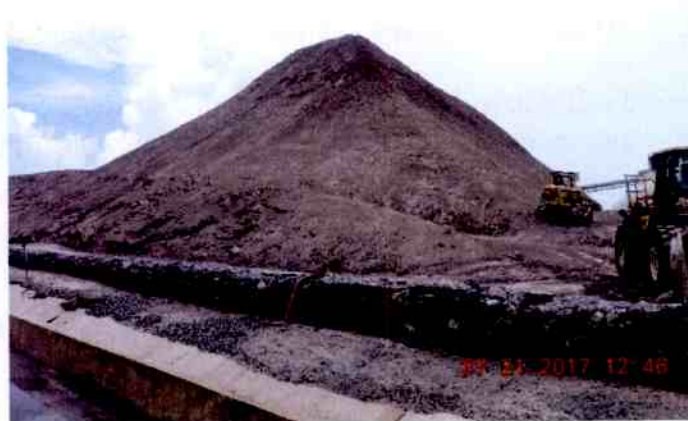
Picture 11

i. **Finding 9** (Picture 11 depicts this observation):

- ⇒ The gabion barrier filter fabric was in disrepair on the west side area of the Agremax pile. Agremax accumulation was observed in said gabion area, which reduces this best management practice capacity to filter storm water.

MSGP Requirement: Part 2.1.2.3 (maintain all control measures in effective operating conditions).

- ⇒ Remove material from the buffer zone between the bottom of the Agremax pile and the gabion structure.
⇒ Replace filter fabric.

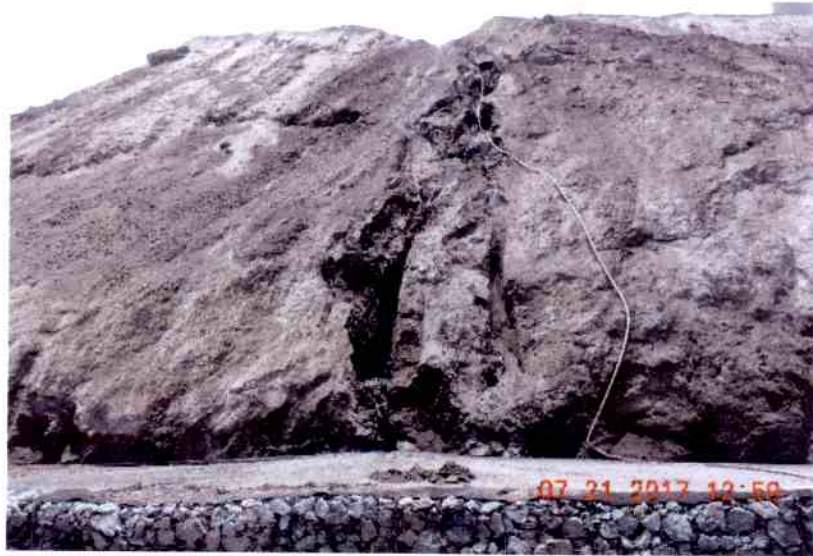
Picture 12

j. **Finding 10** (Picture 12 depicts this observation):

- ⇒ A slope on the south side of the Agremax pile had eroded and Agremax reached the bottom of the slope, but was retained by the gabion structure.

MSGP Requirement: Part 3.1 (routine facility inspections), Part 2.1.2.3 (maintenance) and Part 2.1.2.5 (erosion and sediment control).

- ⇒ Monitor and reinforce the side of the slope to prevent Agremax from overreaching the gabion structure.
